# Repair of Earthquake-Damaged Square R/C Columns with Glass Fiber-Reinforced Polymer

**Abstract:** This paper presents an experimental study on seismic repair of damaged square reinforced concrete columns with poor lap splices, 90-degree hooks and widely spaced transverse bars in plastic hinge regions according to ACI detailing (pre.1971) and (318-02) using GFRP wraps. Three specimens were tested in "as built" condition and retested after they were repaired by glass fiber-reinforced plastic sheets. They were tested under numerous reversed lateral cyclic loading with a constant axial load ratio. FRP composite wraps were used for repairing of concrete columns in critically stressed areas near the column footings. Physical and mechanical properties of composite wraps are described. Seismic performance and ductility of the repaired columns in terms of the hysteretic response are evaluated and compared with those of the original columns. The results indicated that GFRP wraps can be an effective repair measure for poorly confined R/C columns due to short splice length and widely spaced ties with 90-degree anchorage hooks. Both flexural strength and ductility of repaired columns were im

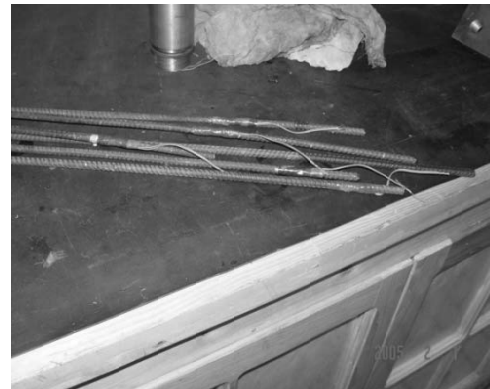
**Fig.4** Strain gauges were installed on the bars
